HO-419

Holly House Farm  
12402 Lime Kiln Road  
Private

## Maryland Inventory of Historic Properties Form

Inventory No. HO-419

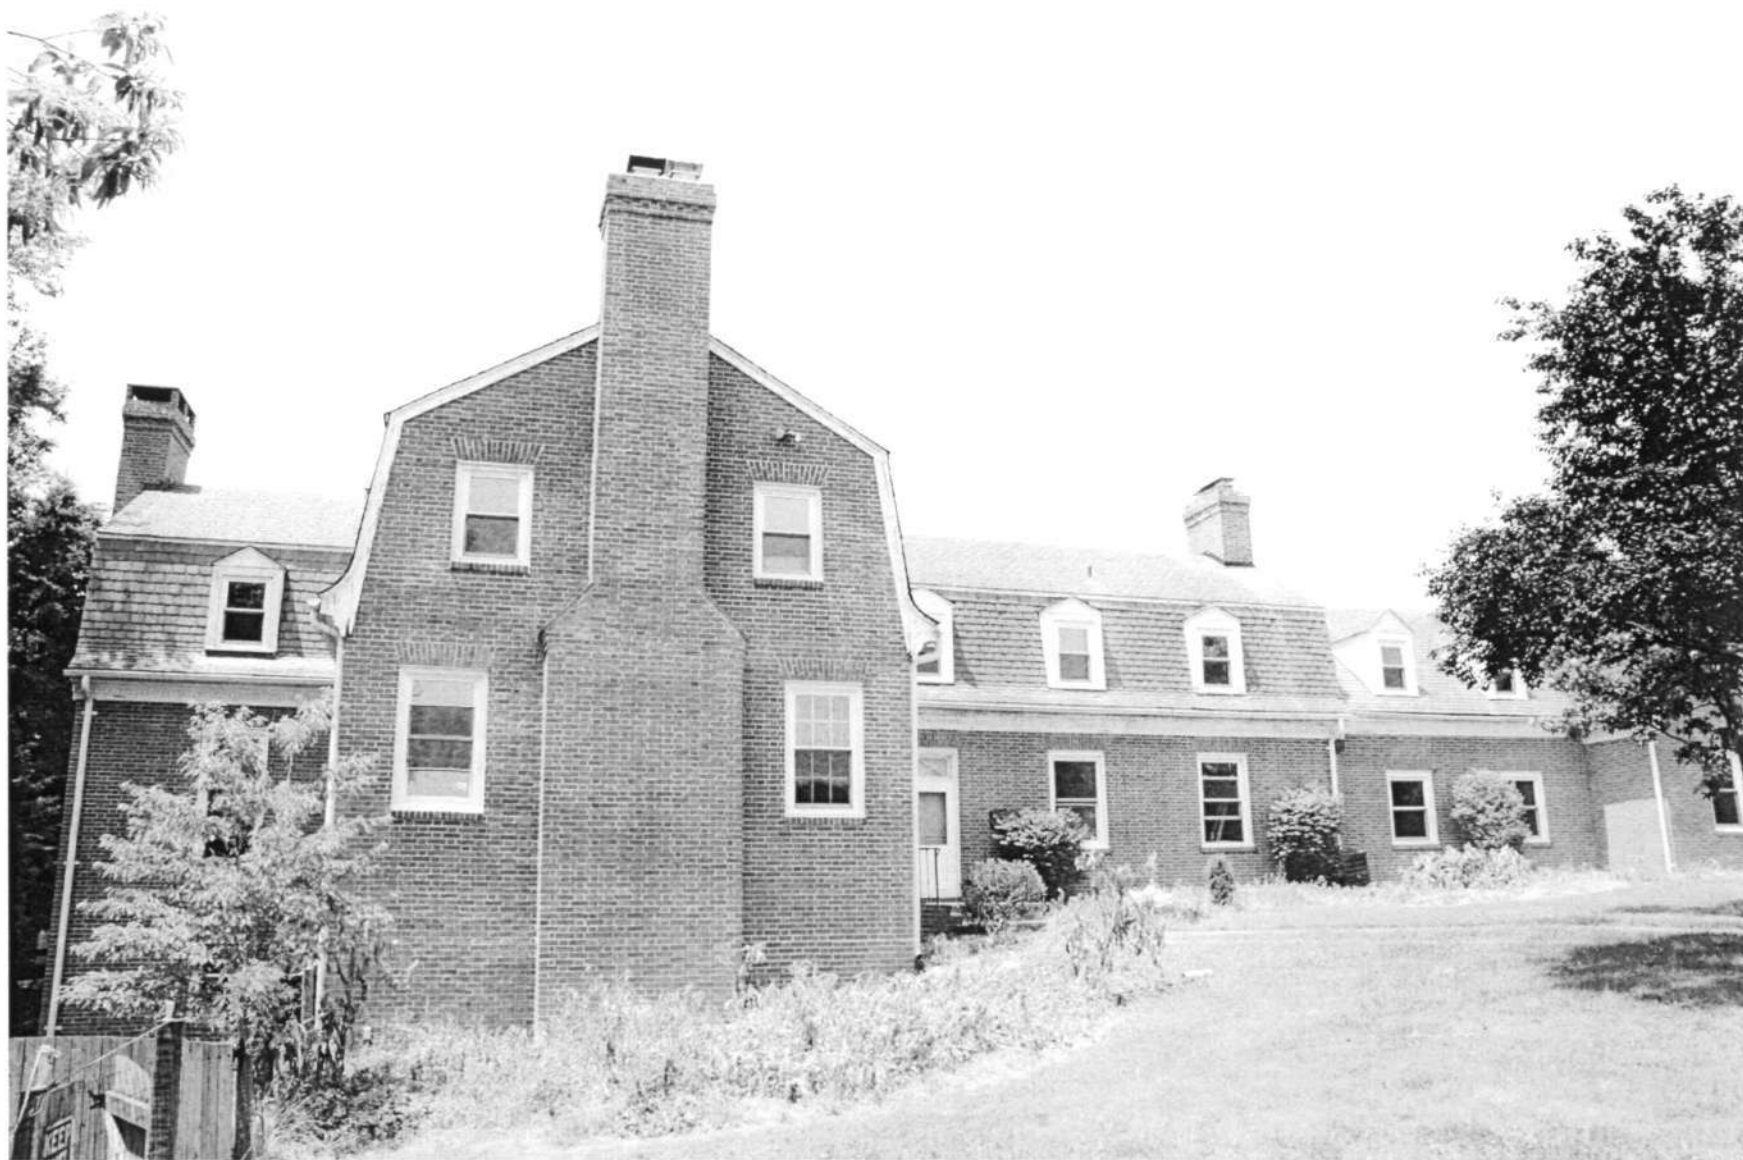
HO-419 Holly House Farm 12402 Lime Kiln Road House, east elevation  
Ken Short, June 2006 1/18

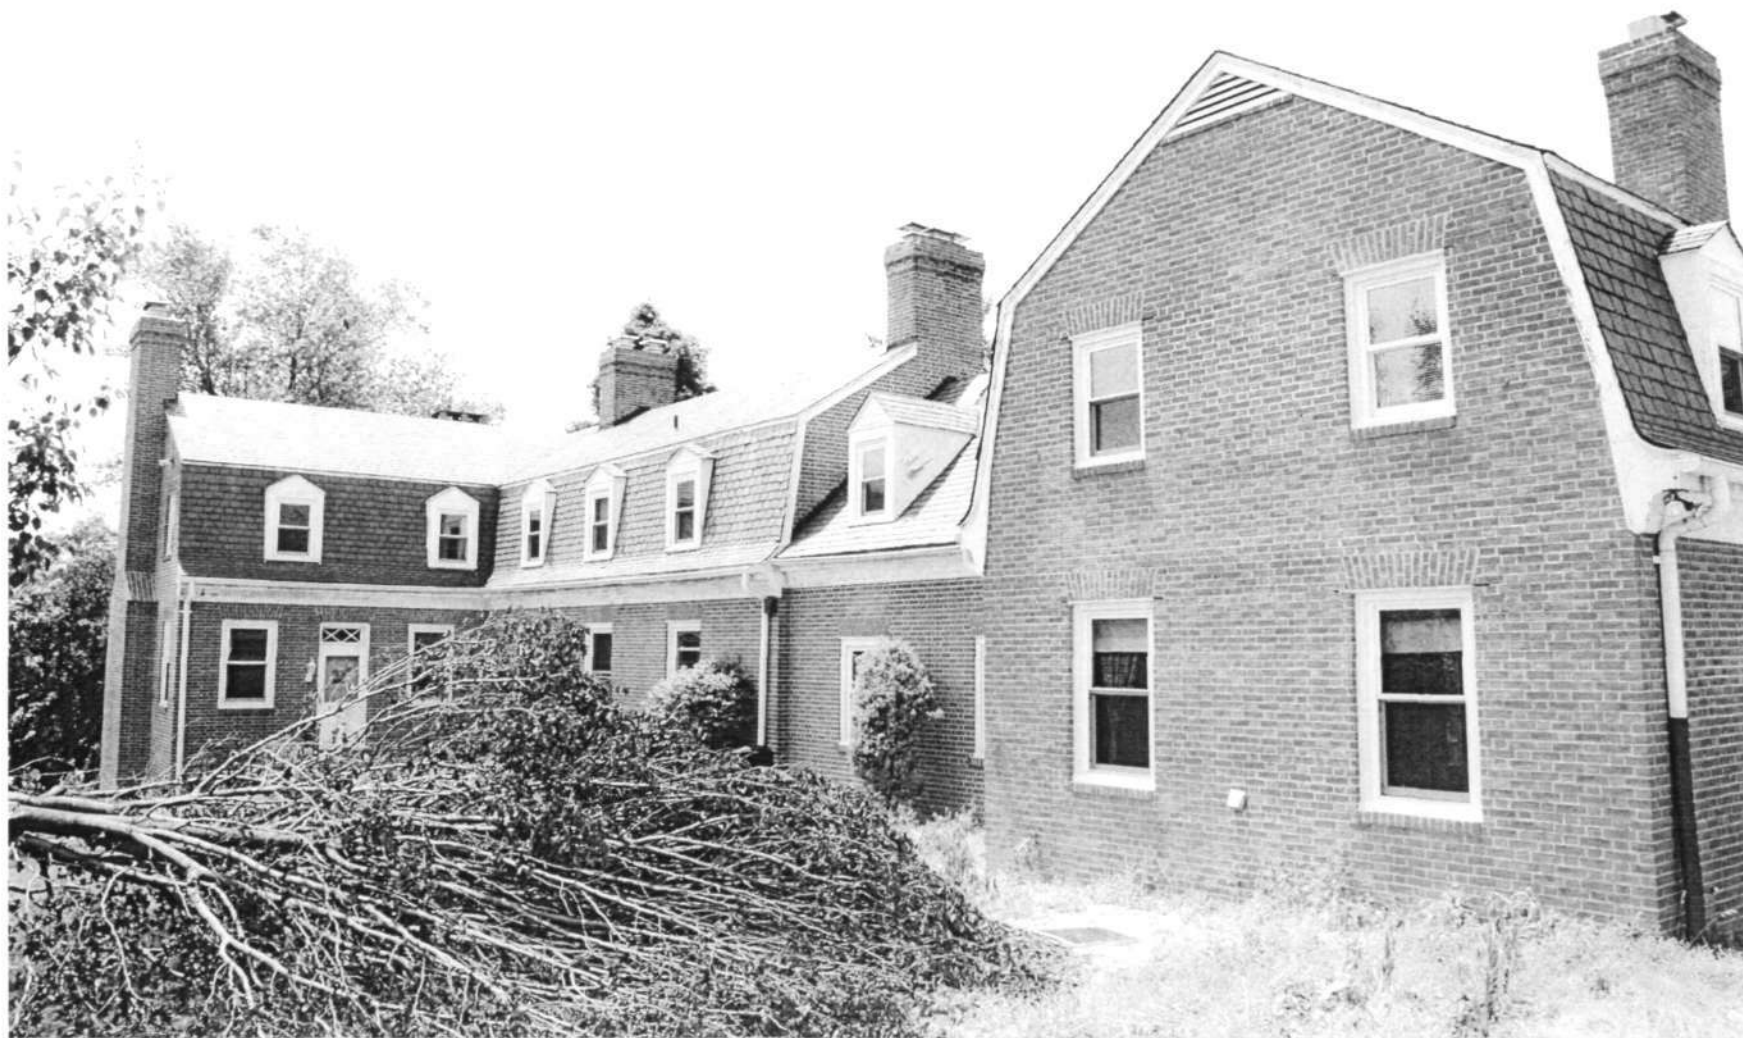
HO-419 Holly House Farm 12402 Lime Kiln Road House, east elevation, fr. north  
Ken Short, June 2006 2/18

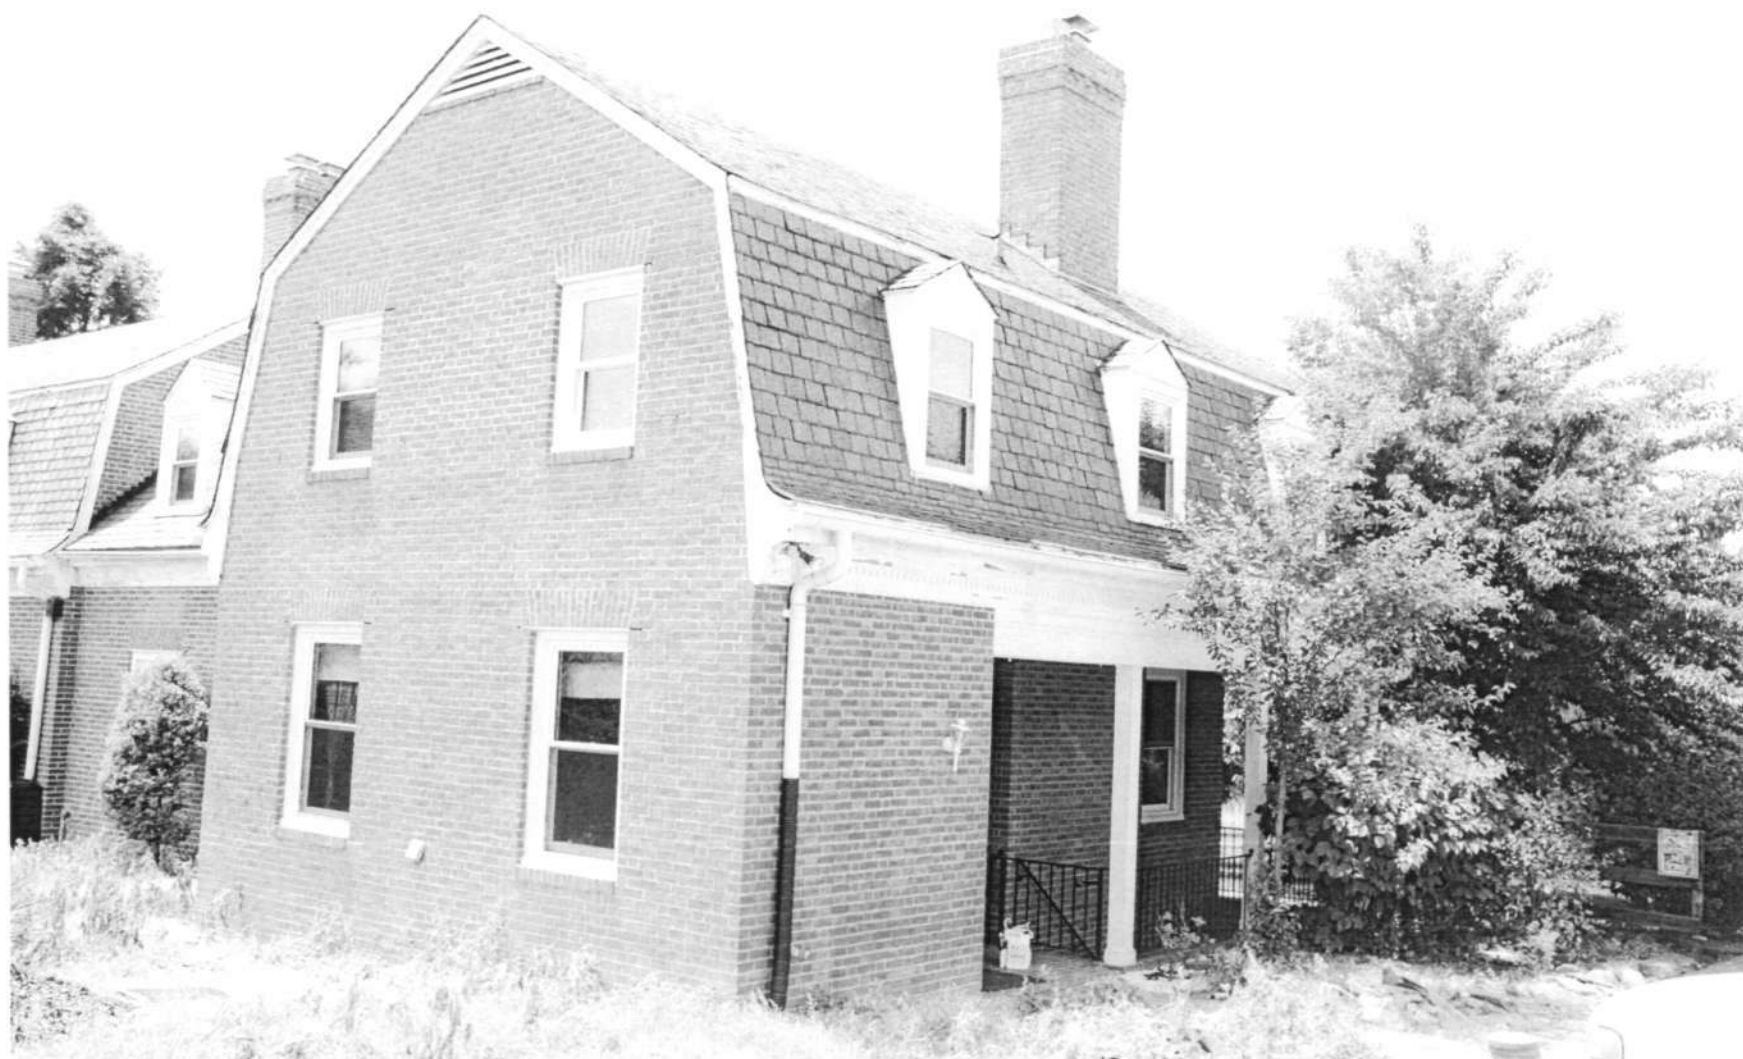
HO-419 Holly House Farm 12402 Lime Kiln Road House, east & north elevations  
Ken Short, June 2006 3/18

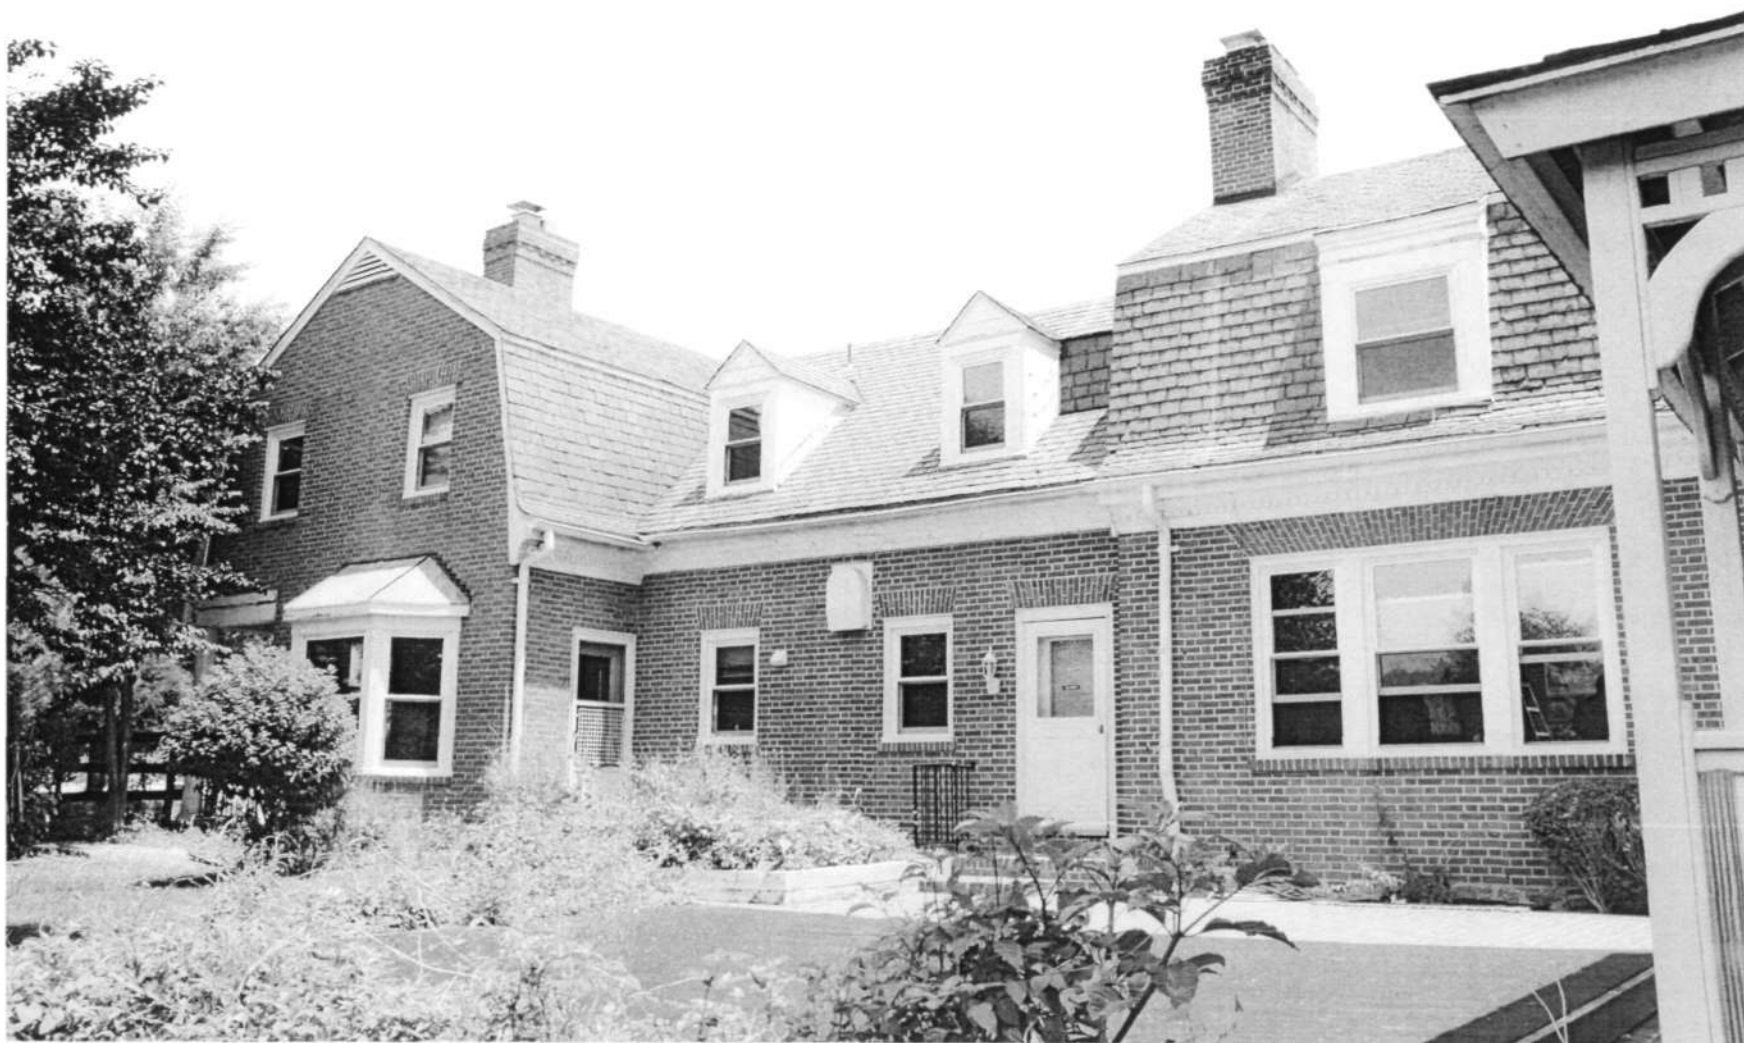
HO-419 Holly House Farm 12402 Lime Kiln Road House, west elevation  
Ken Short, June 2006 4/18

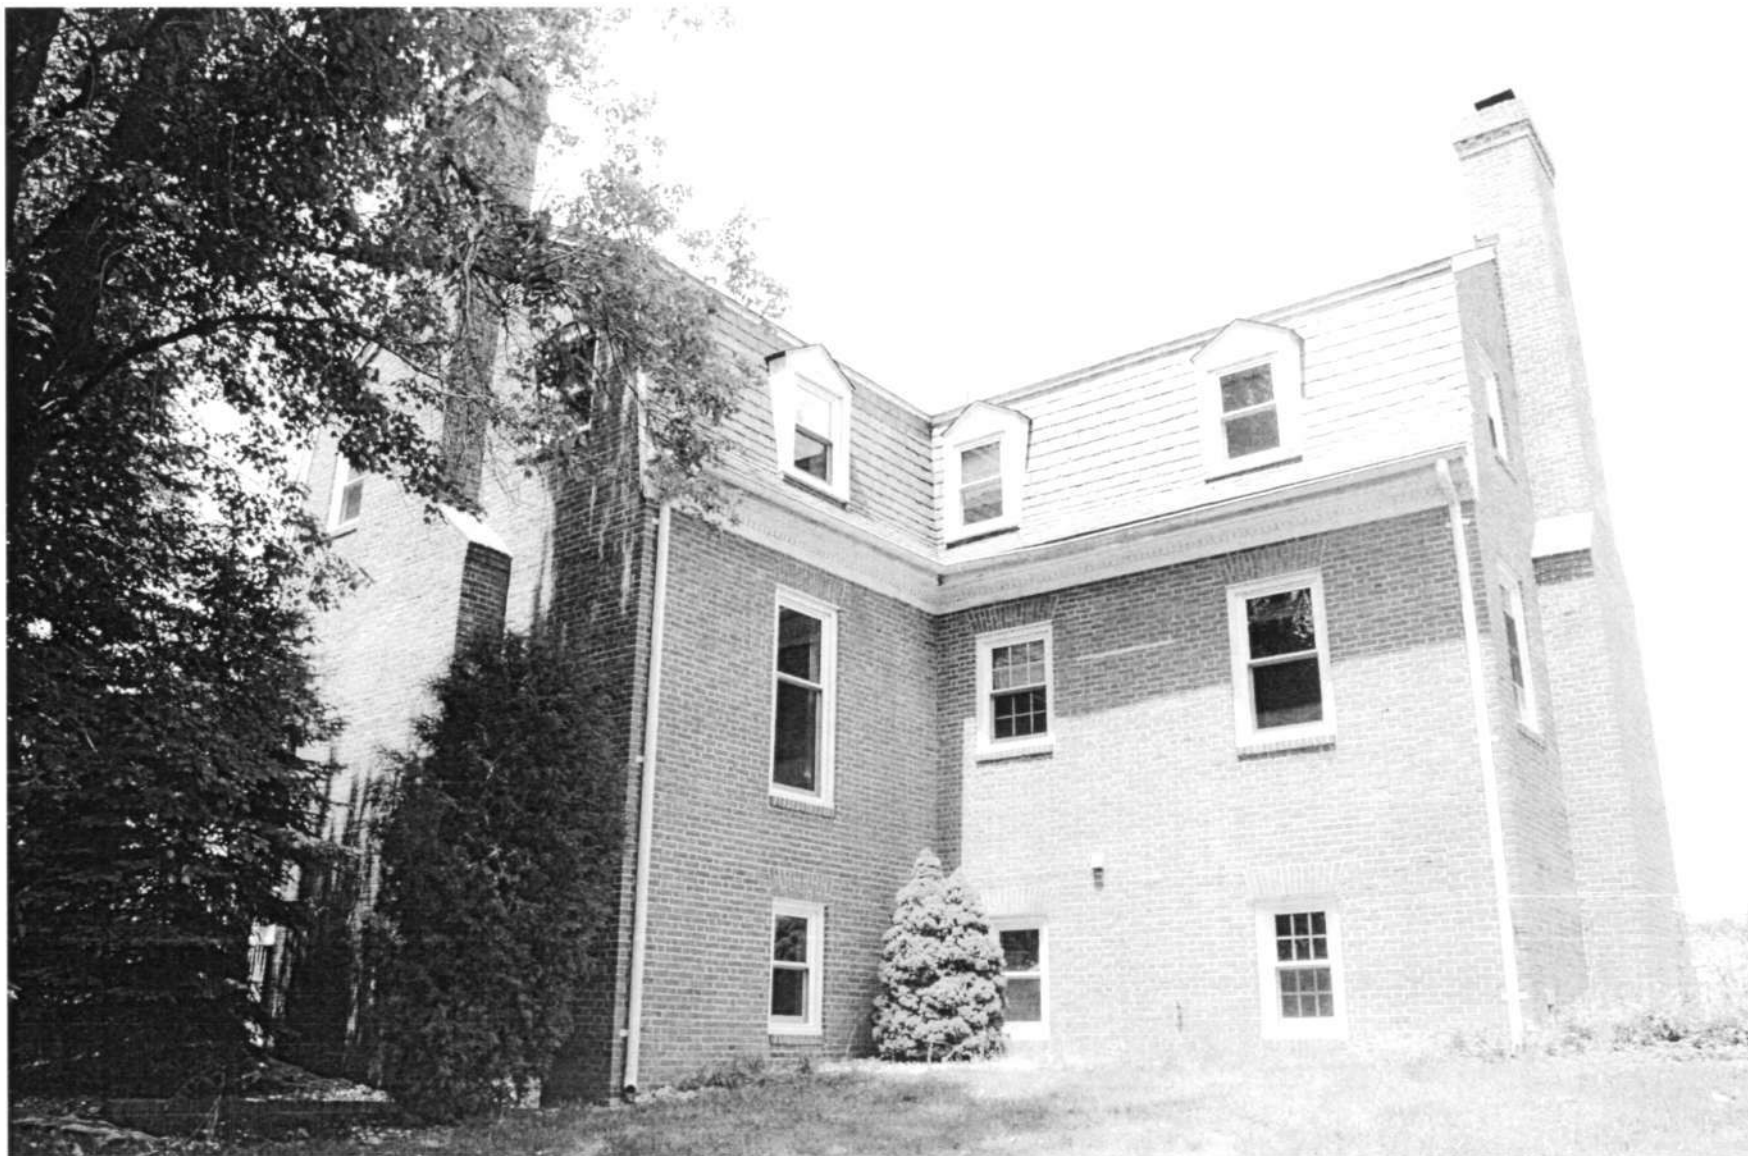
HO-419 Holly House Farm 12402 Lime Kiln Road House, south elevation  
Ken Short, June 2006 5/18

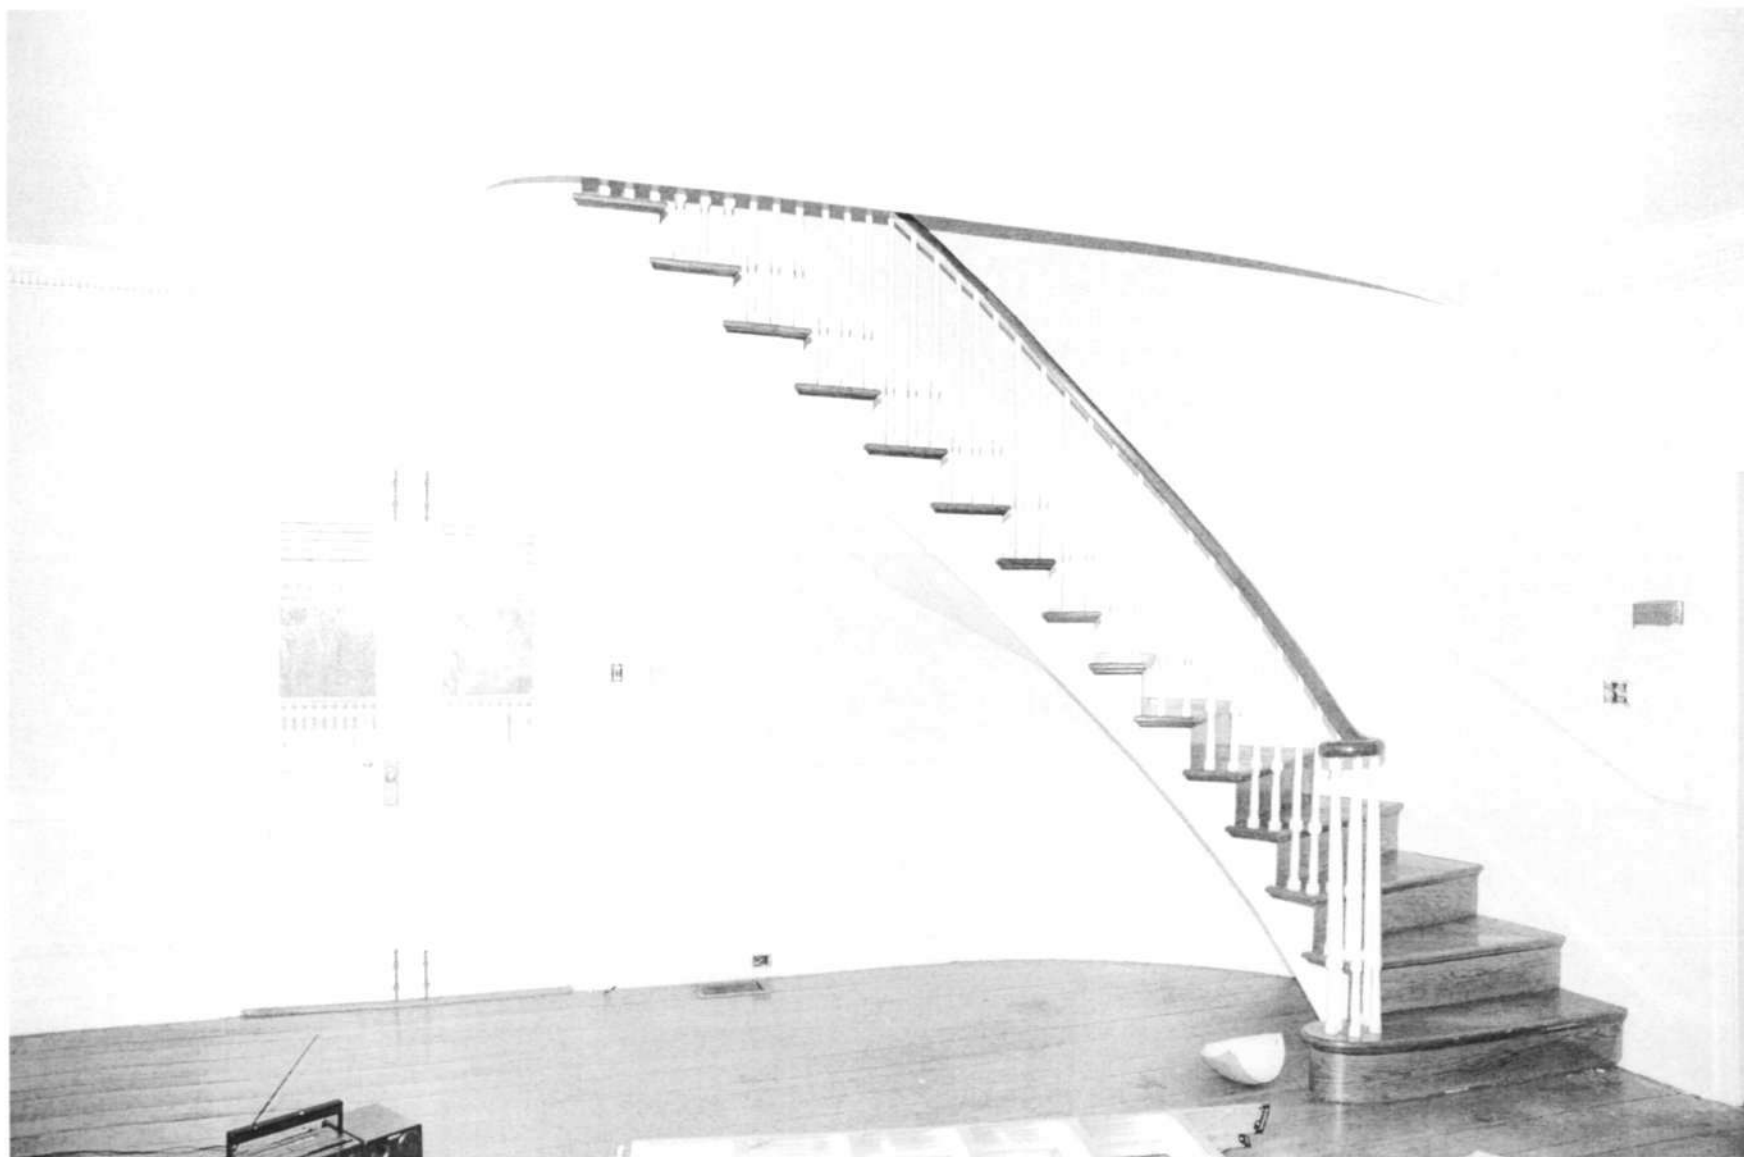
HO-419 Holly House Farm 12402 Lime Kiln Road House, stairhall, vw. west  
Ken Short, June 2006 6/18

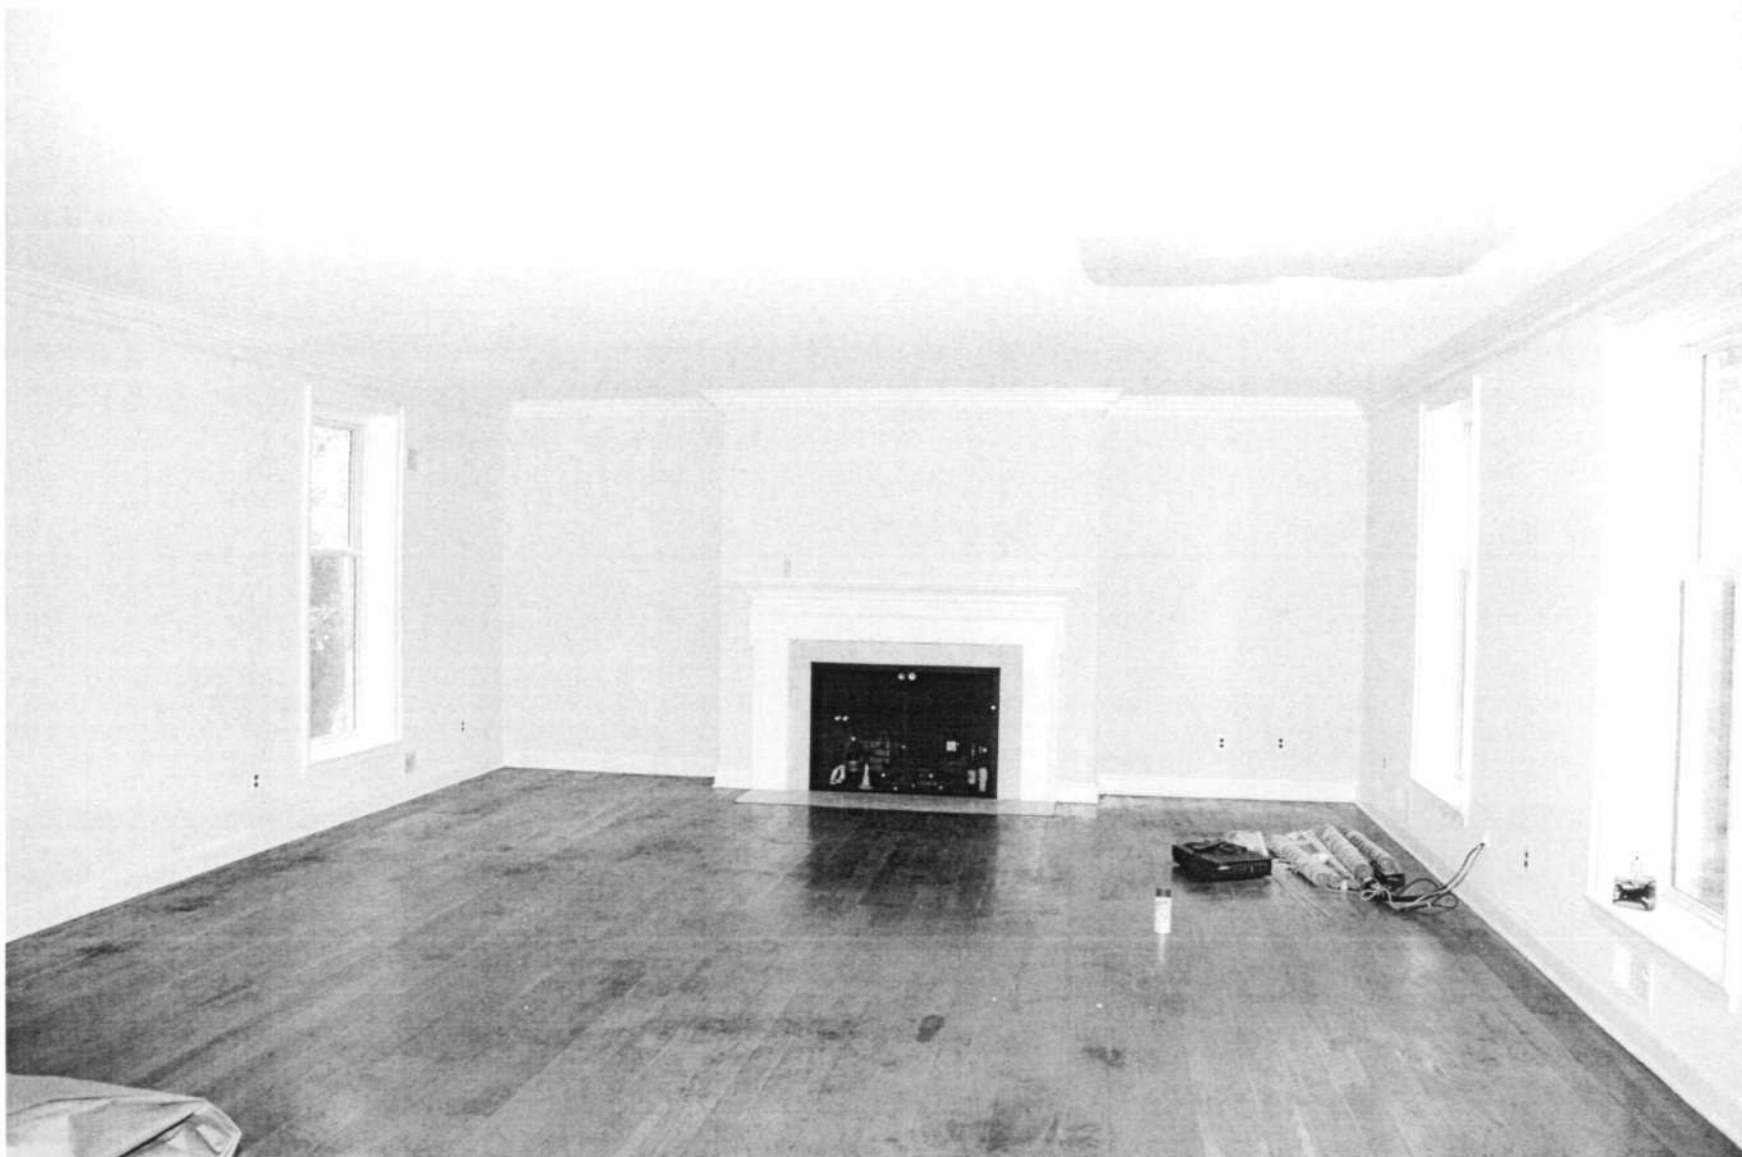
The south room has the same flooring, architrave, doors, and cornice. There is a fireplace on the south elevation with firebrick, a white marble hearth and surround, and a wood mantel with shouldered architrave, a pulvinated frieze, and dentils. This mantel is also not very old. The east room has carpeting, modern paneling, and typical architrave. The east elevation has a fireplace with a raised hearth, firebrick, and new wood bolection mouldings. There is a bathroom off of this room that contains a sink on chrome legs, and chrome towel bars.

HO-419 Holly House Farm 12402 Lime Kiln Road House, south room, vw. south  
Ken Short, June 2006 7/18

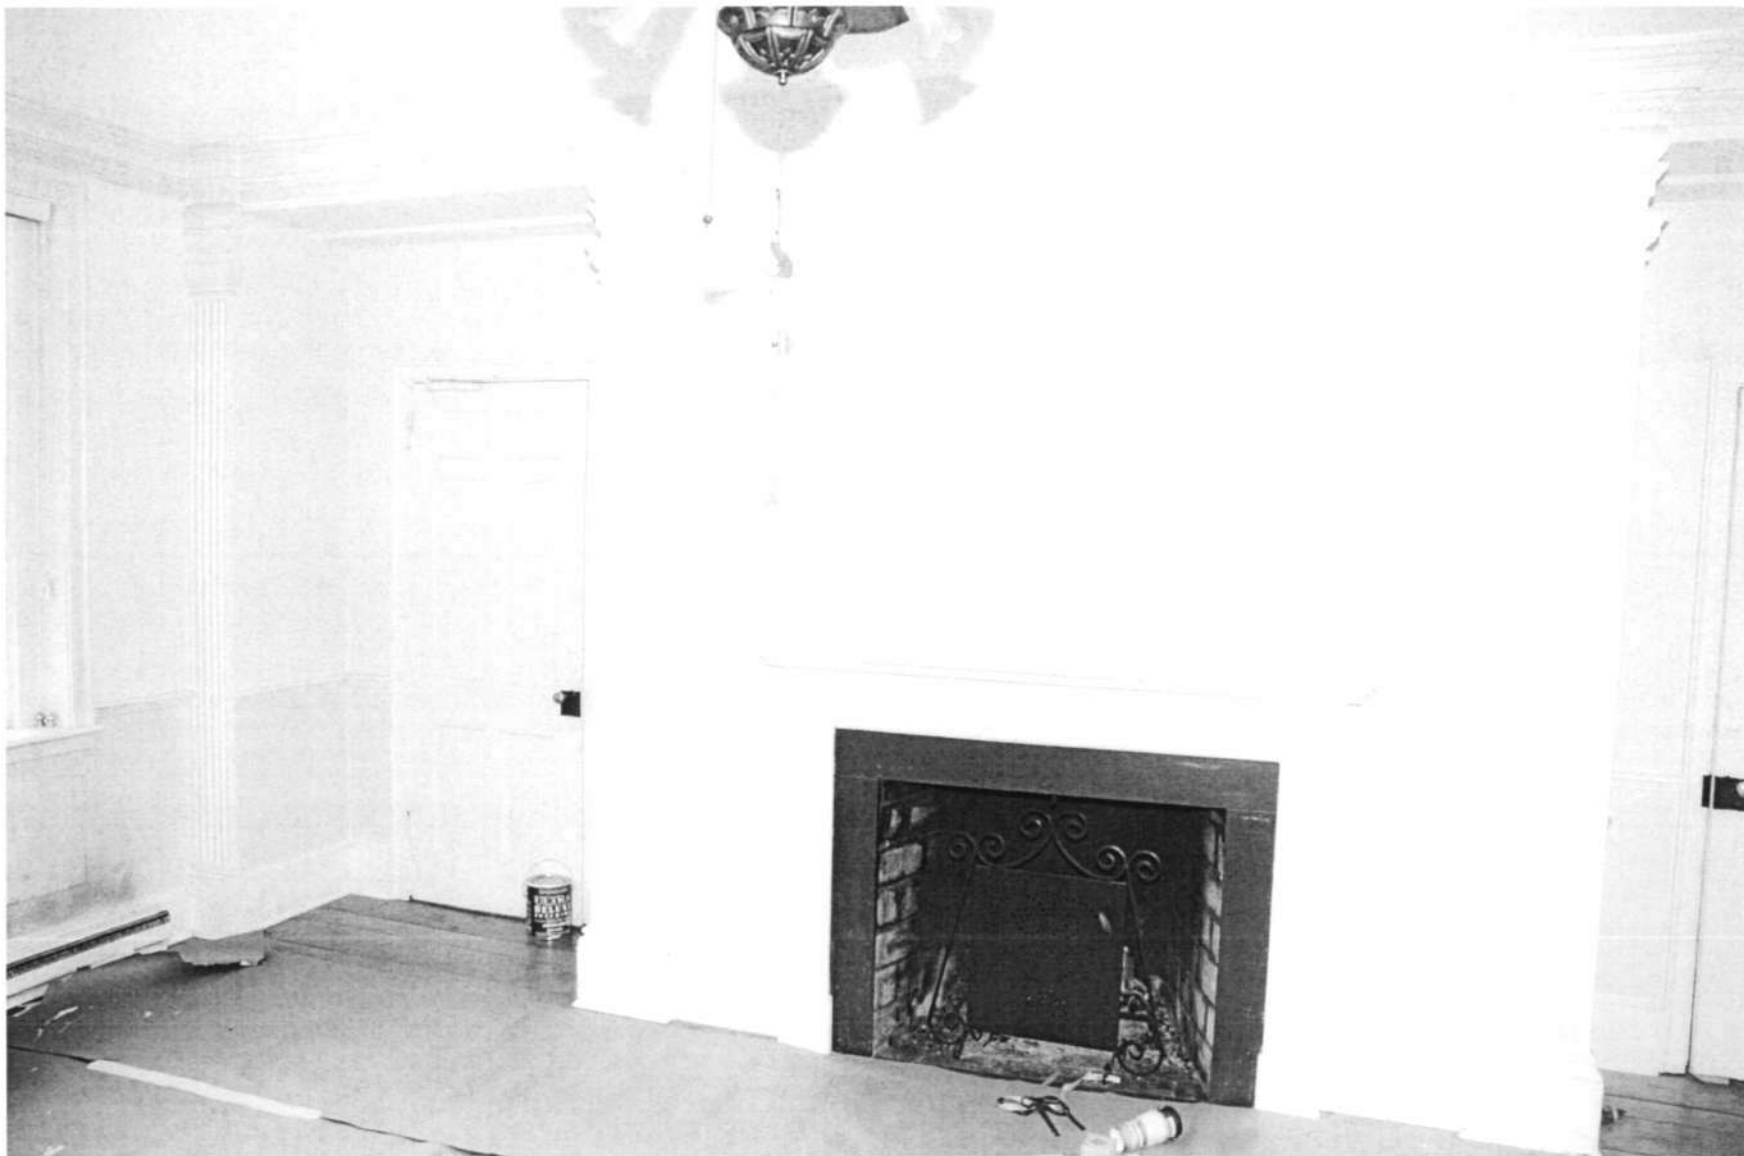
The center room has typical flooring, architrave, and chair rail. There is a fireplace on the north elevation that has firebrick and the same mantel that is found in the stair hall. The cornice in this room has an ogee above an ogee, with small dentils and an ogee at the bottom. The cornice is not the same as that in the other rooms, and could possibly be older. The north wall has four fluted pilasters with pieces of architrave and pulvinated frieze above, all set below the cornice of the room. The north-center room has a quarry tile floor, typical architrave, an enclosed stair at the south end, and a modern kitchen. The north room has a quarry tile floor, exposed brick on the walls, and a fake beam ceiling. The north elevation has a fireplace with a raised hearth and a metal stove insert. There is typical architrave and doors, and there are two small rooms at the east end.

HO-419 Holly House Farm 12402 Lime Kiln Road House, center room, vw. north  
Ken Short, June 2006 8/18

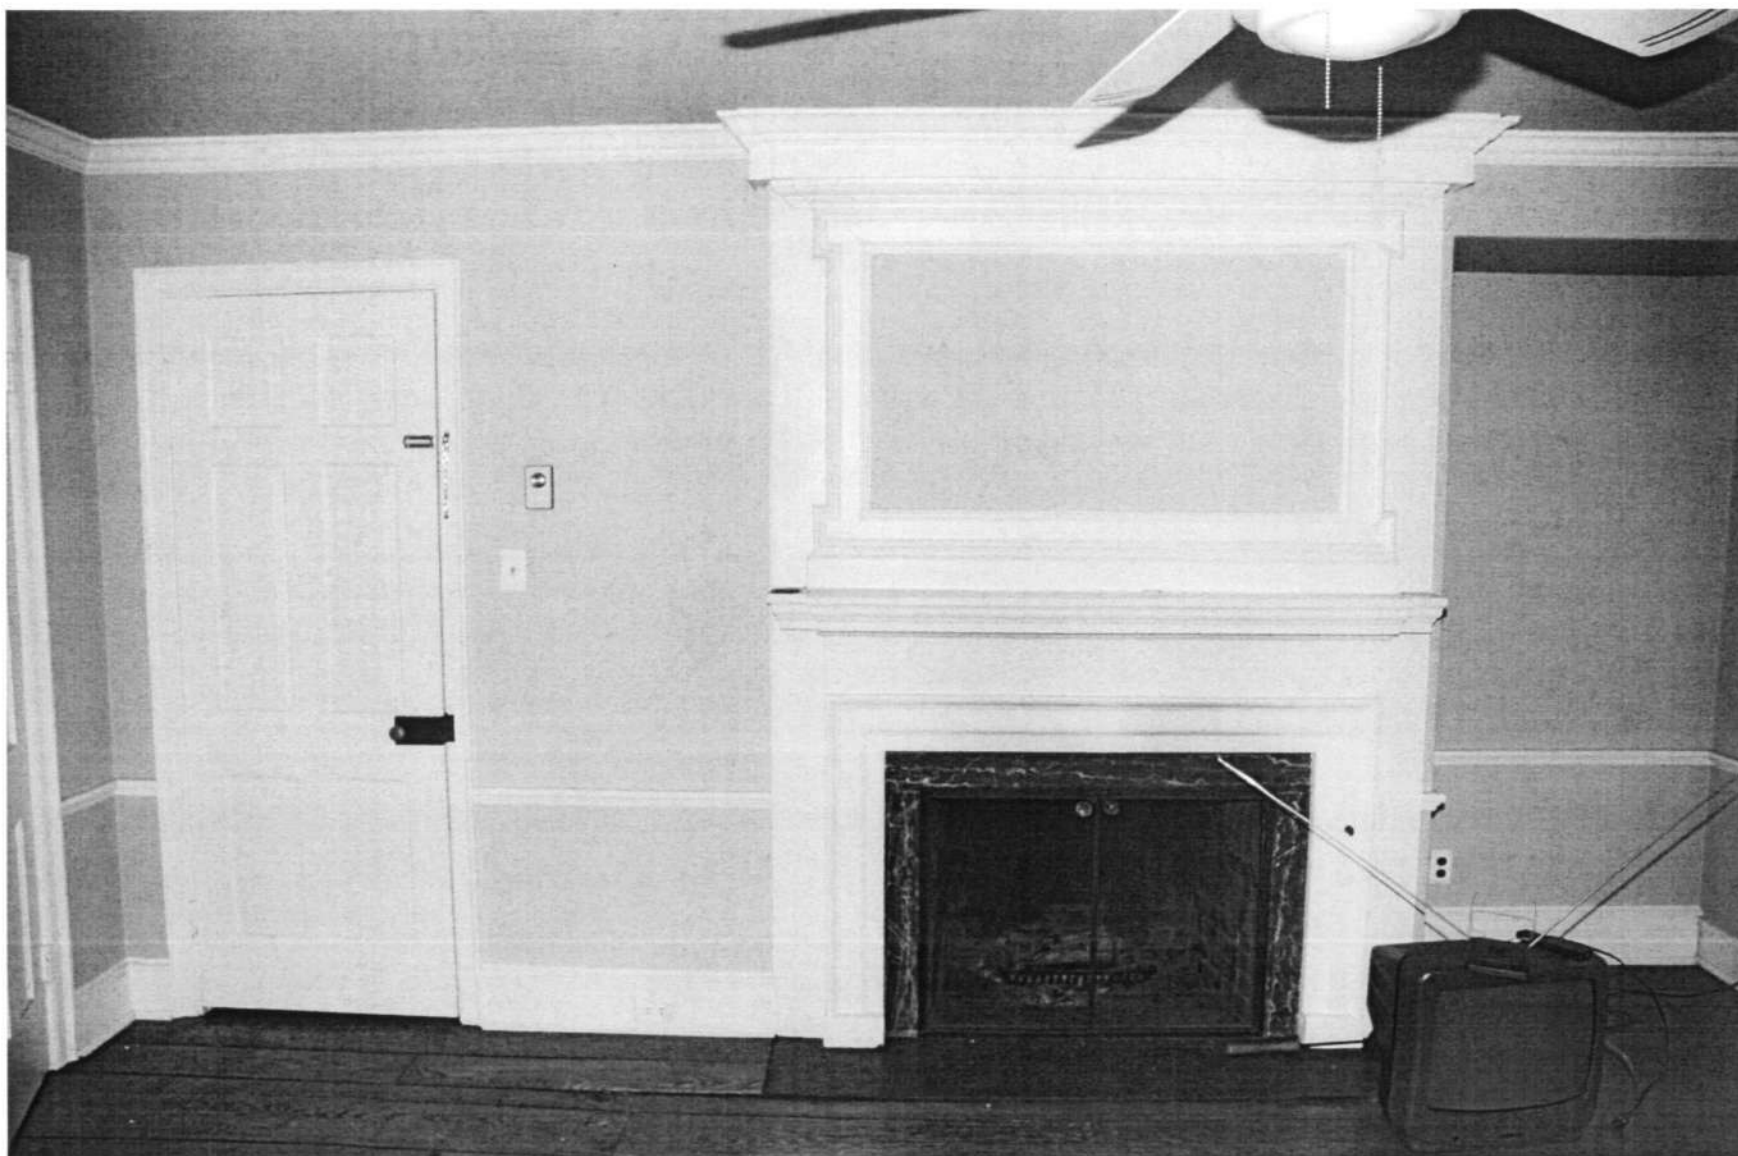
HO-419 Holly House Farm 12402 Lime Kiln Road House, center chamber, vw, north  
Ken Short, June 2006 9/18

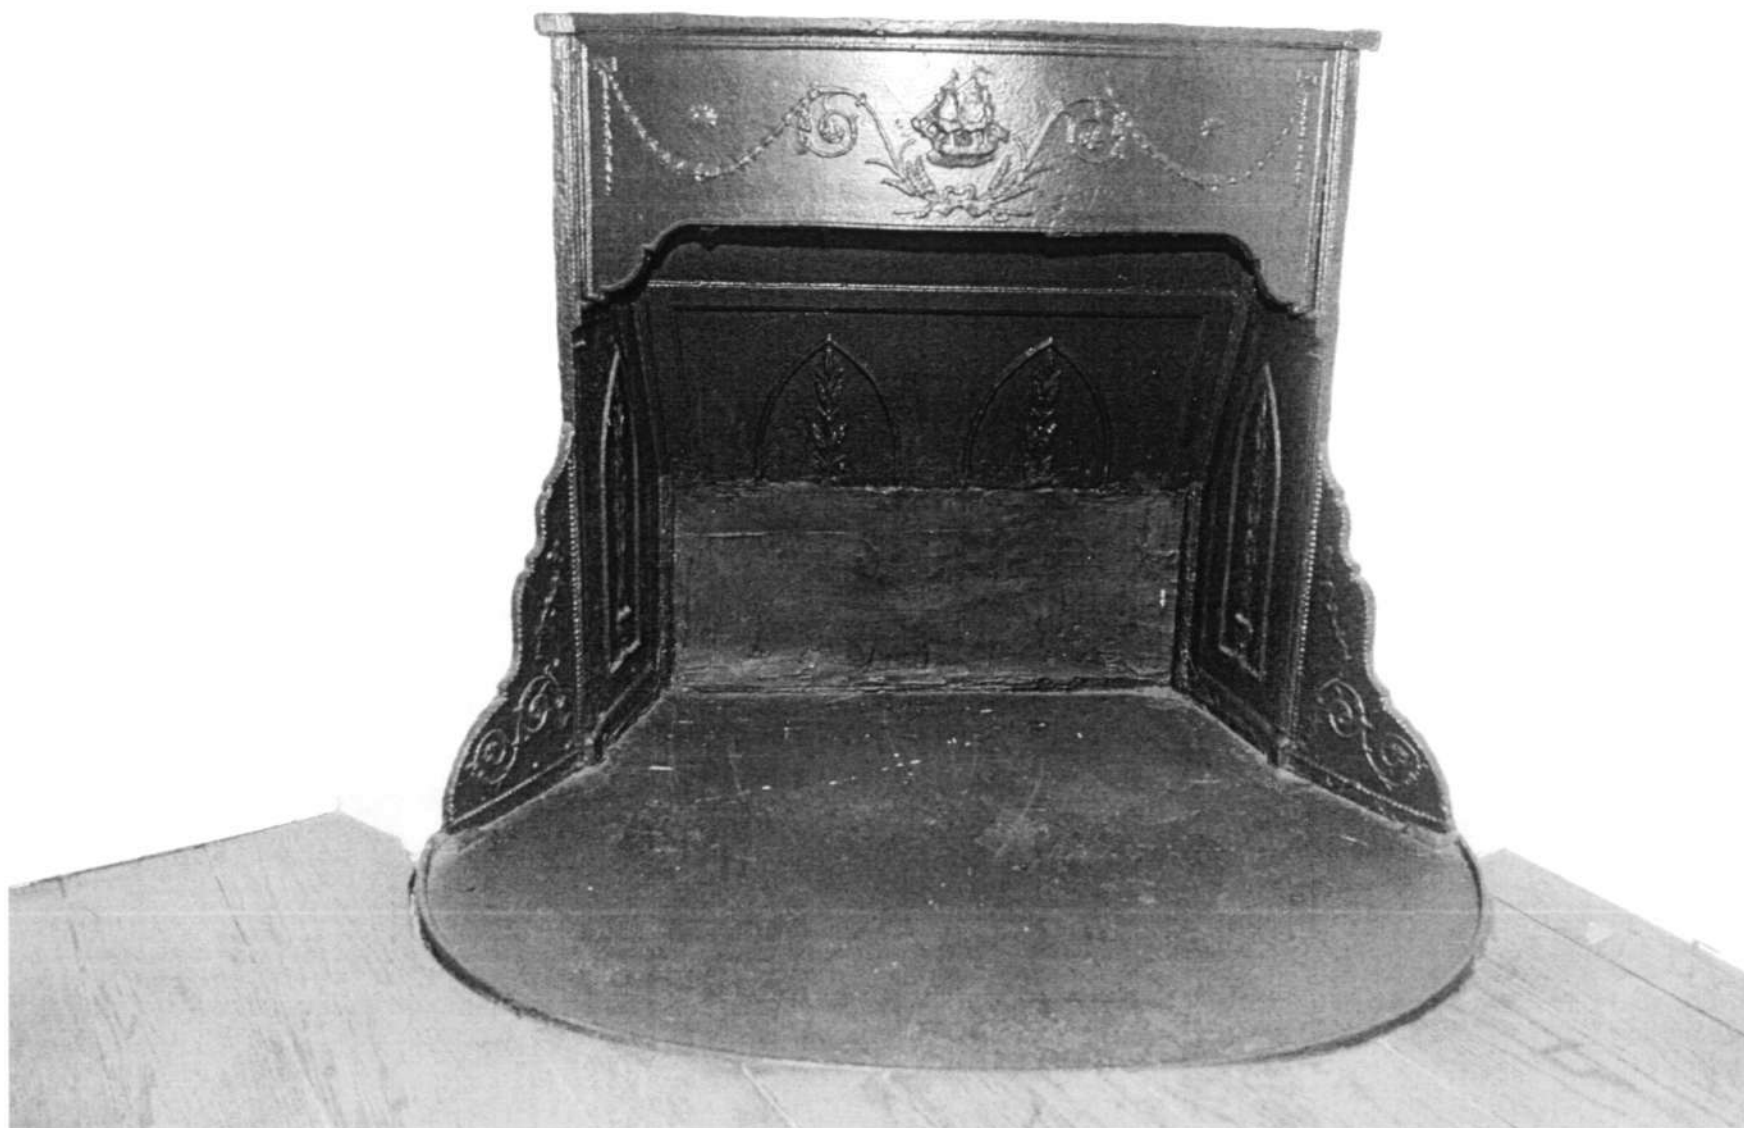
HO-419 Holly House Farm 12402 Lime Kiln Road House, southeast chamber over stair hall, Franklin stove  
Ken Short, June 2006 10/18

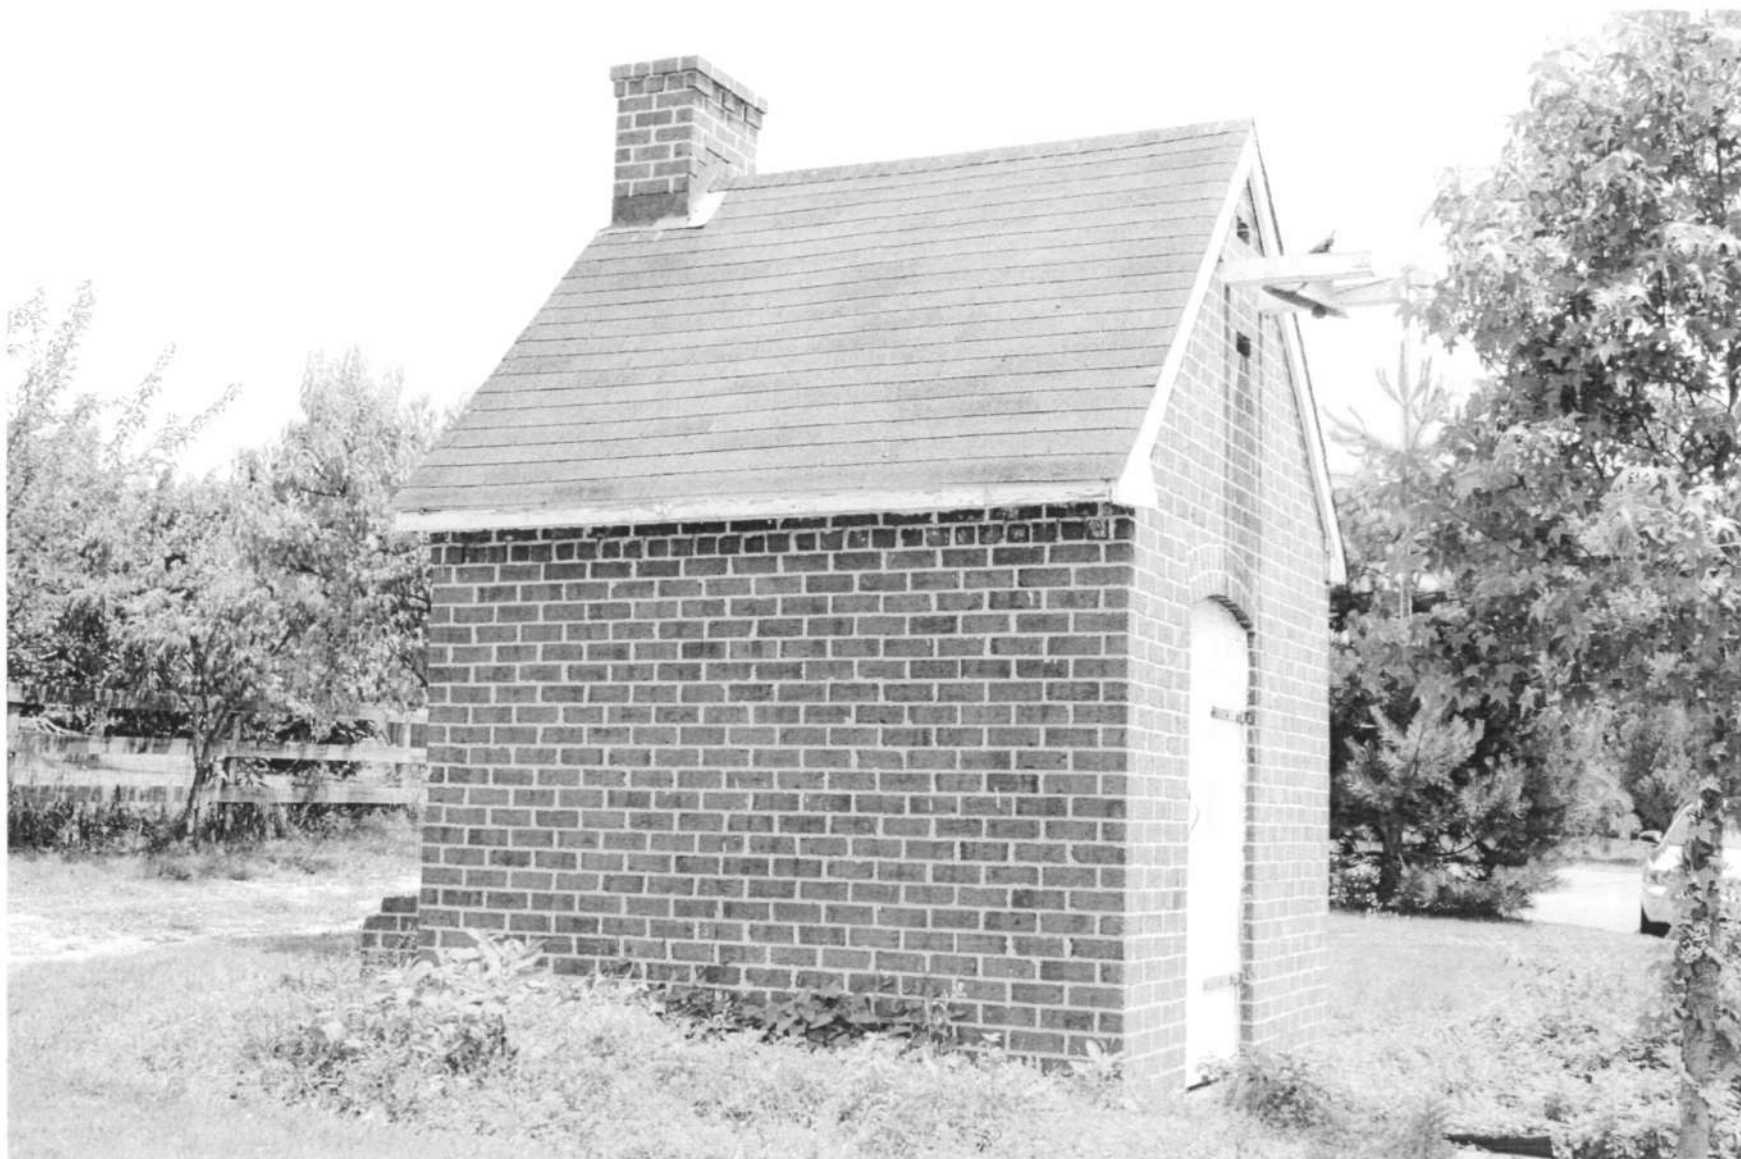
There is a small brick outbuilding located about 30 feet northeast of the house. It is a one-story, one-bay square structure of running bond brick that is newer than the brickwork in the house. It has a gable roof with a north-south ridge and asphalt shingles. There is an interior chimney on the north end with a barbecue attached here on the exterior, and the barbecue has partially collapsed. The south elevation has a semi-circular arched doorway with a vertical board door hung on machine-made strap hinges. There are four openings in the brickwork above the door, and the bricks have holes in them. There was some kind of barbecue pit in the center of the interior of this building.

HO-419 Holly House Farm 12402 Lime Kiln Road Brick outbuilding, west & south elevations  
Ken Short, June 2006 11/18
